SHAW BRIDGE
Claverack, New York

INITIAL SITE VISIT

REPORT

December 13, 2012
Revised December 28, 2013

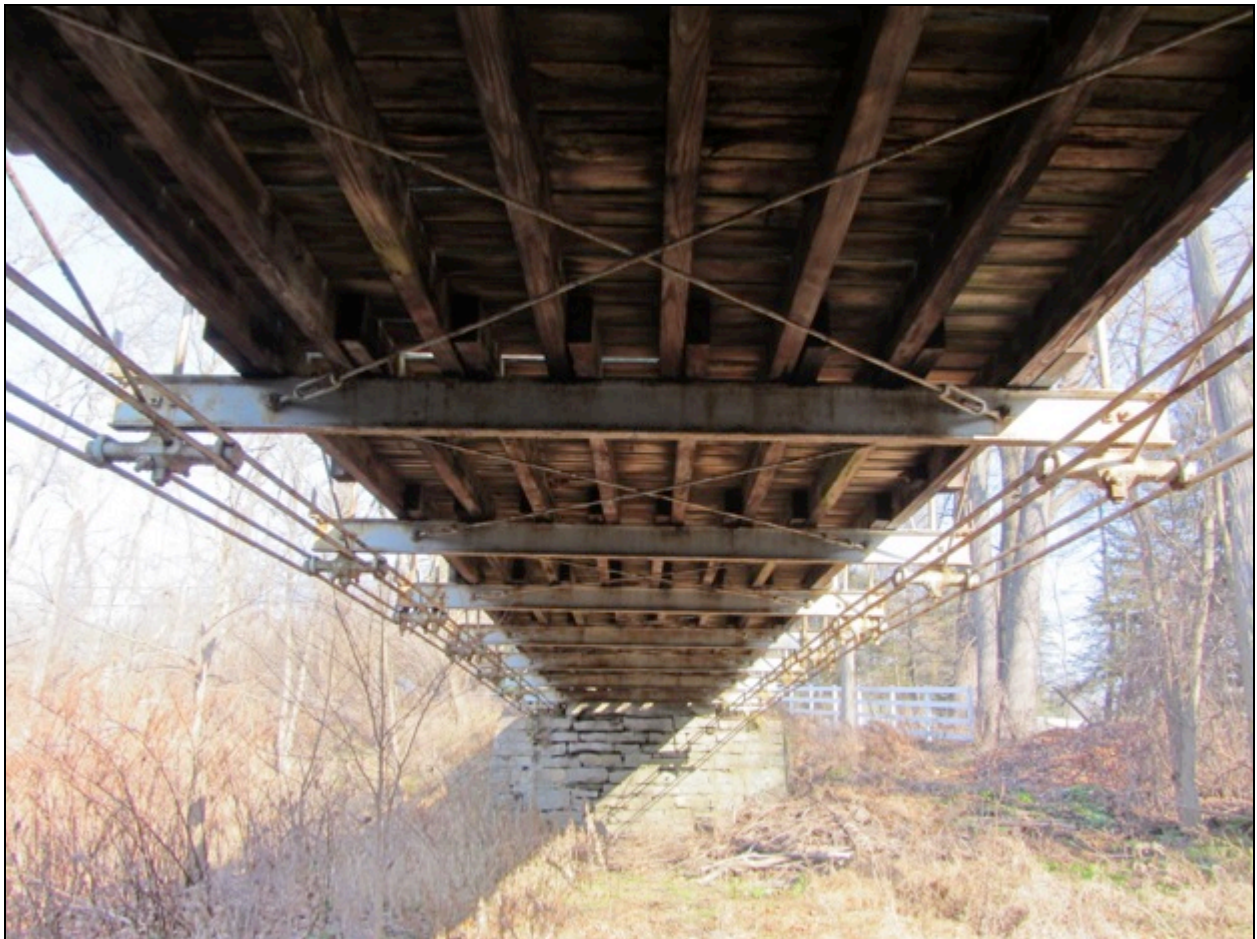
Image taken under the north span looking north

The beams, probably steel and not original, appear to be in fairly good condition. Some rusting on the top flanges is apparent. It is believed that after cleaning they should be reusable.

The diagonal floor bracing also looks okay. The turnbuckles will have to be cleaned and restored to operating condition.

The wooden decking must all be replaced. From a distance it appears that the wooden stringers may be salvageable but prudence would suggest the entire wooden structure be replaced.

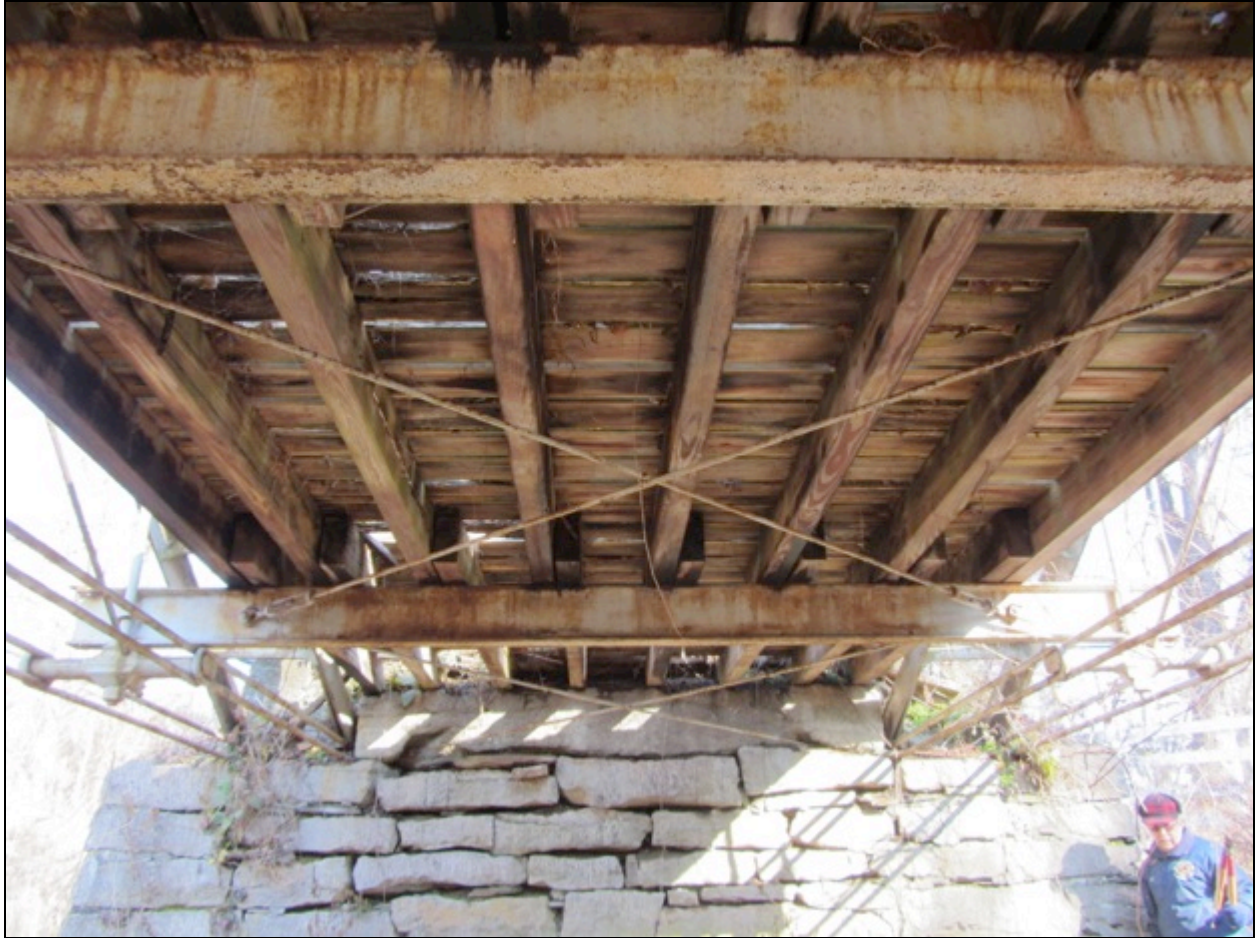
Image taken under north span looking north at north abutment

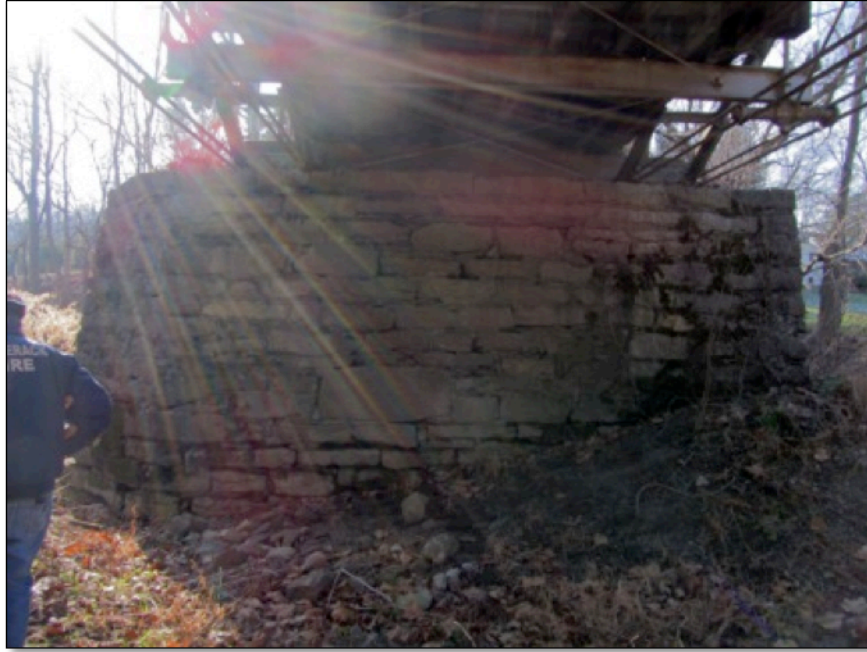
South face, looking north

The rough masonry appears to be stable after over 150 years. No sign of settling or shifting out of plane. Should be usable with only a chipping, prying, out of all loose mortar and re-pointing. The mortar should be forced as far into the masonry as possible using a dry pack mortar. Re-pointing has been attempted in the past. It is not known if the masonry joints were initially mortared but it is likely the stonework was dry laid.

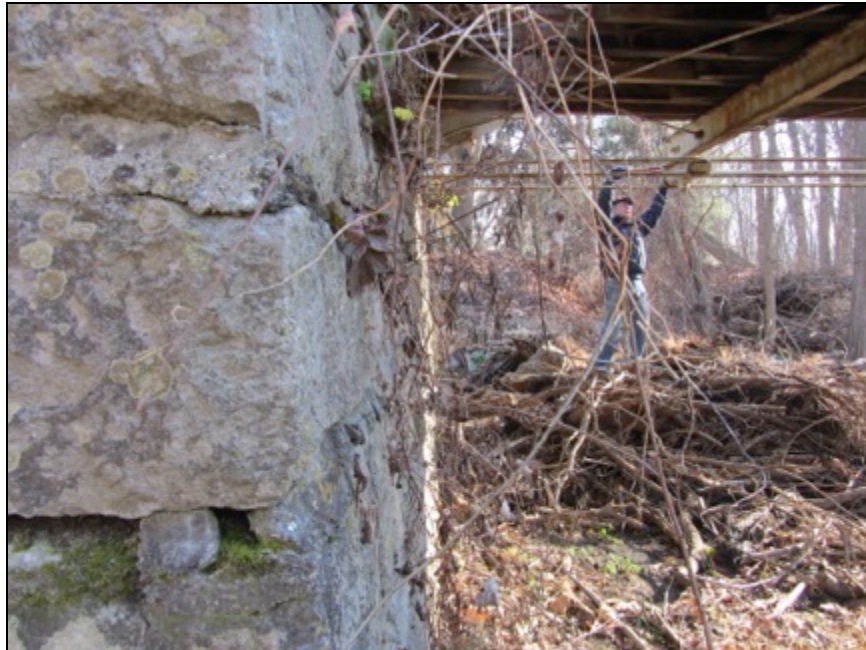
South face, edge view

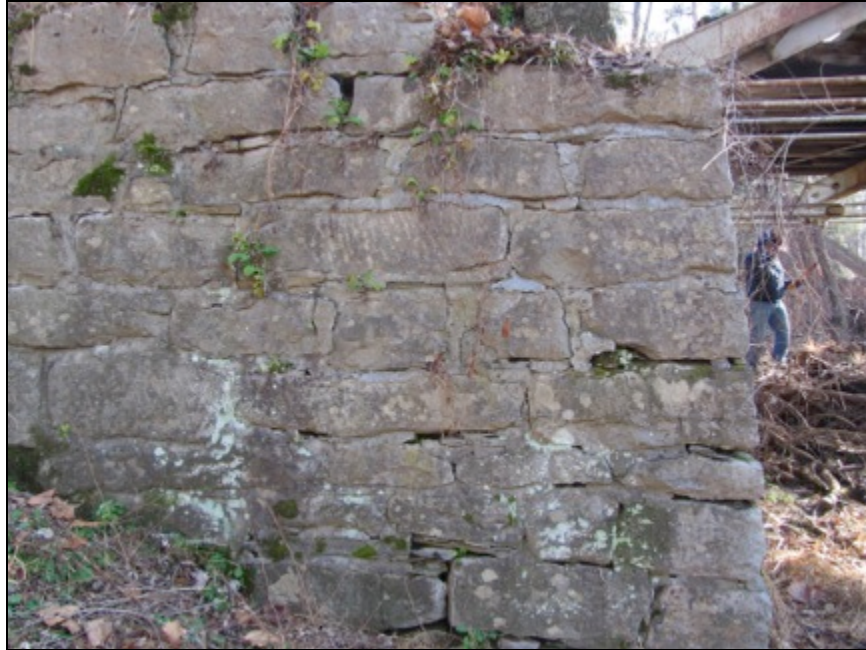
North Abutment west face

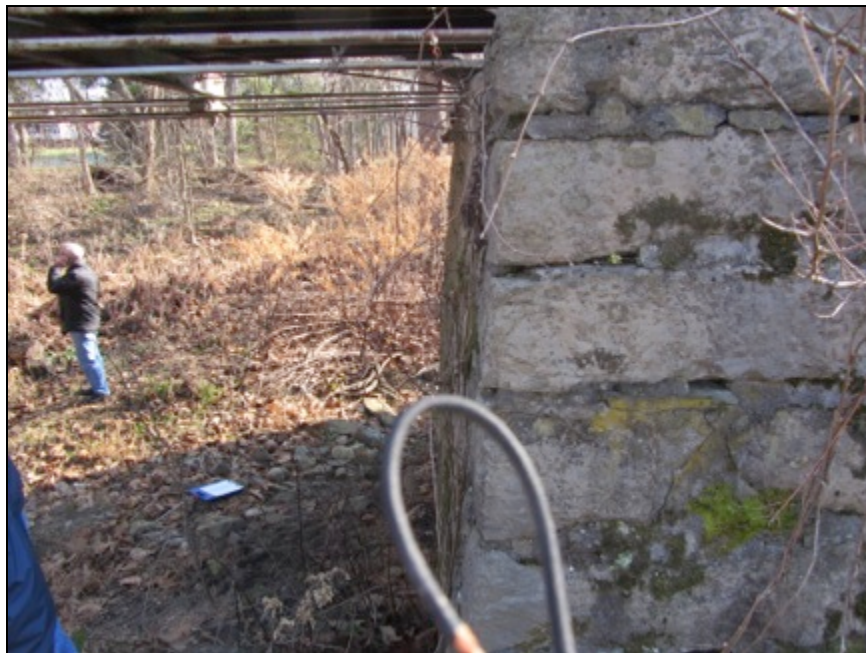
North Abutment, east face

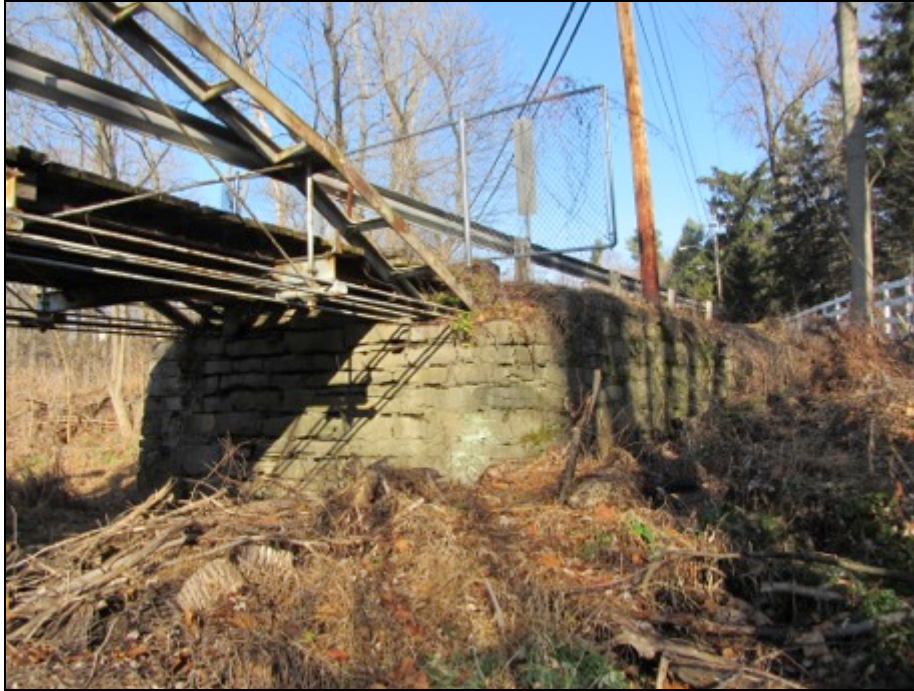
Looking northwest

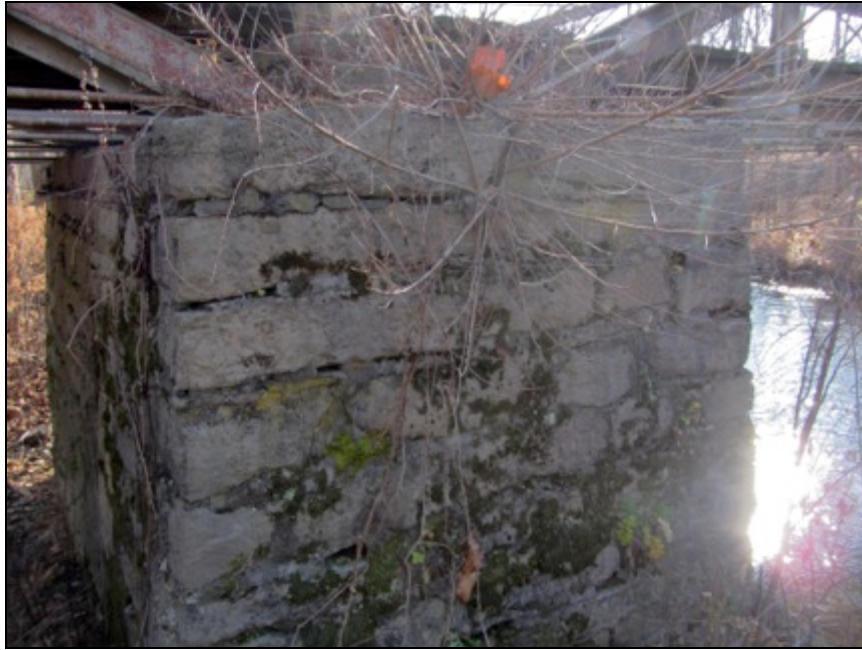
West face

Same as north abutment

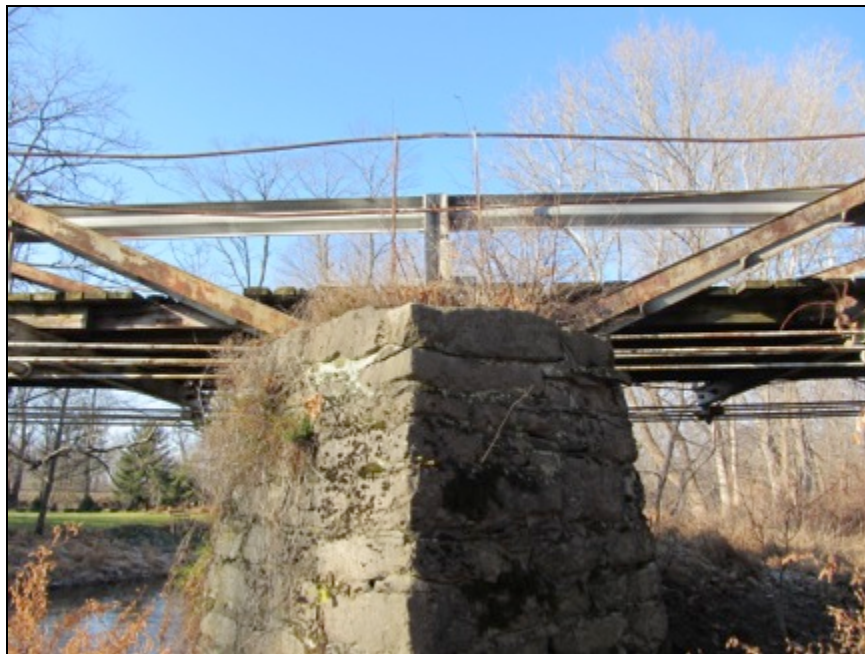
East face, ice breaker

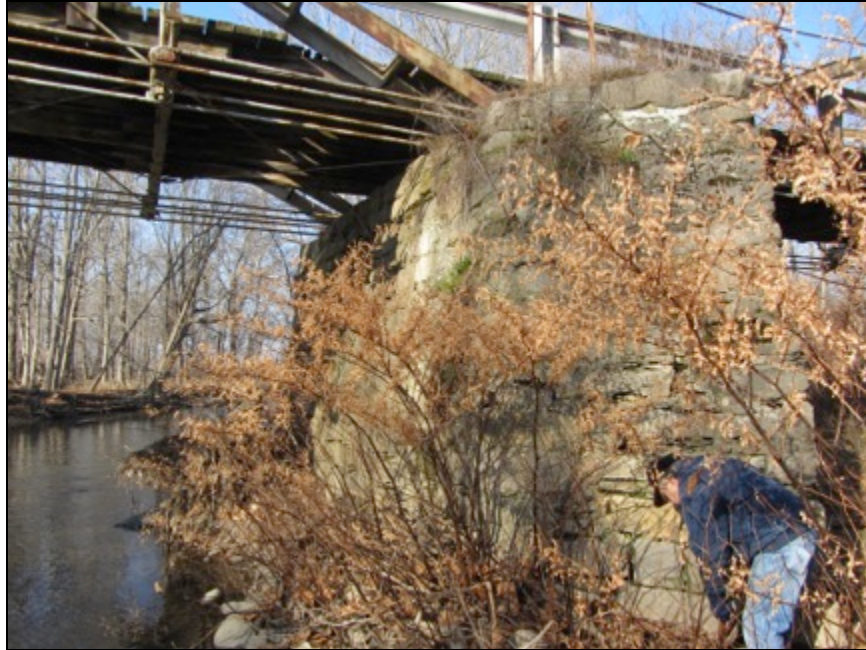
East and south face

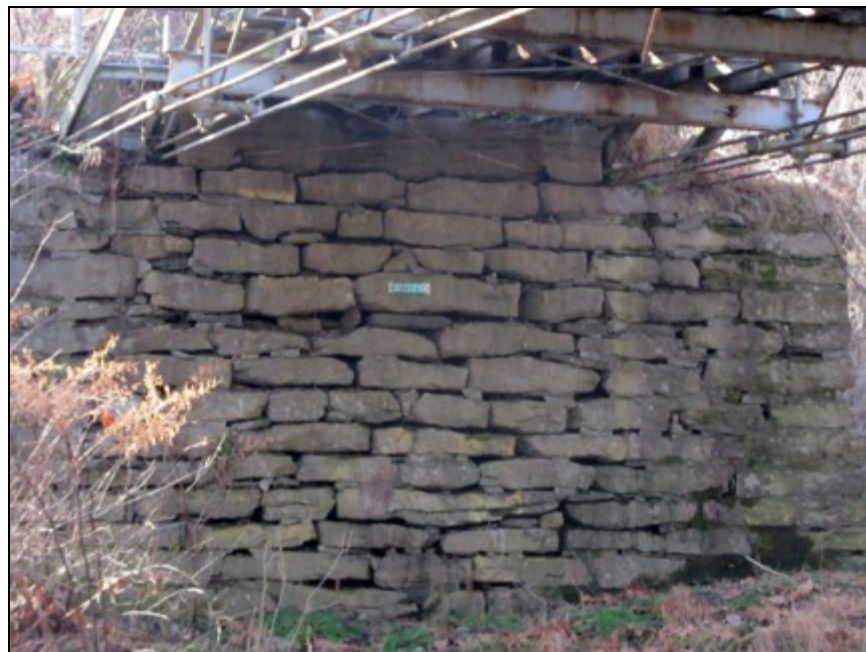
South Abutment, north face

Same as north abutment and central pier

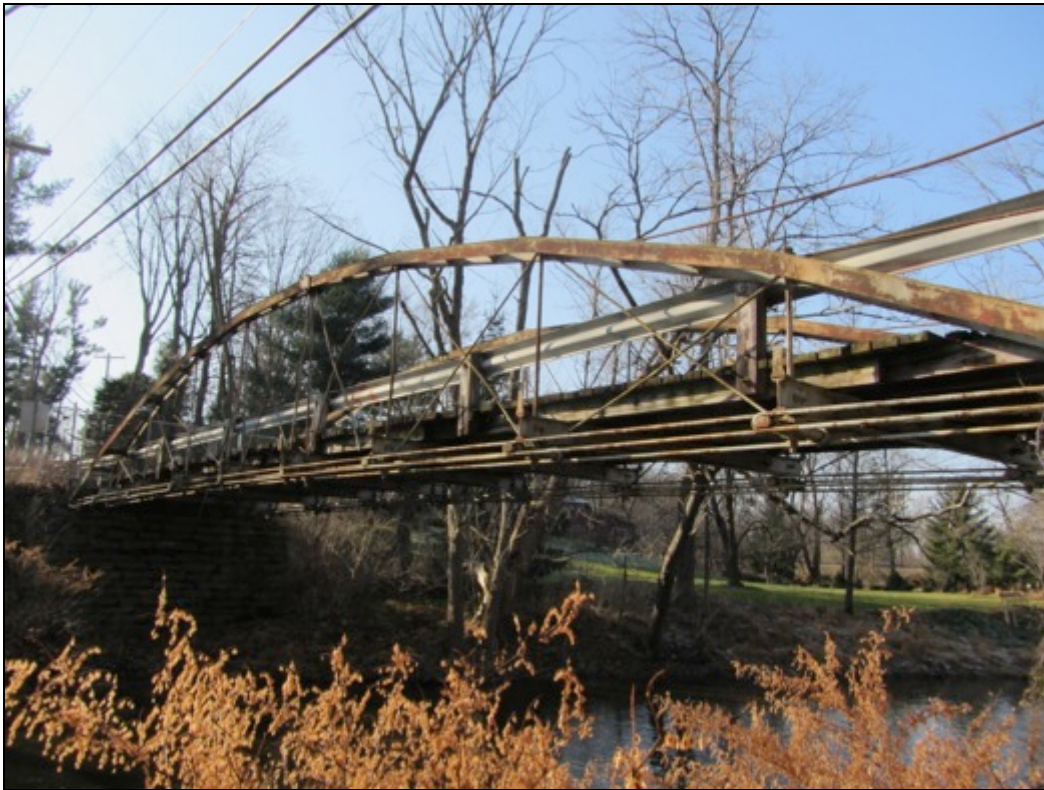
South span, easterly truss, showing creek

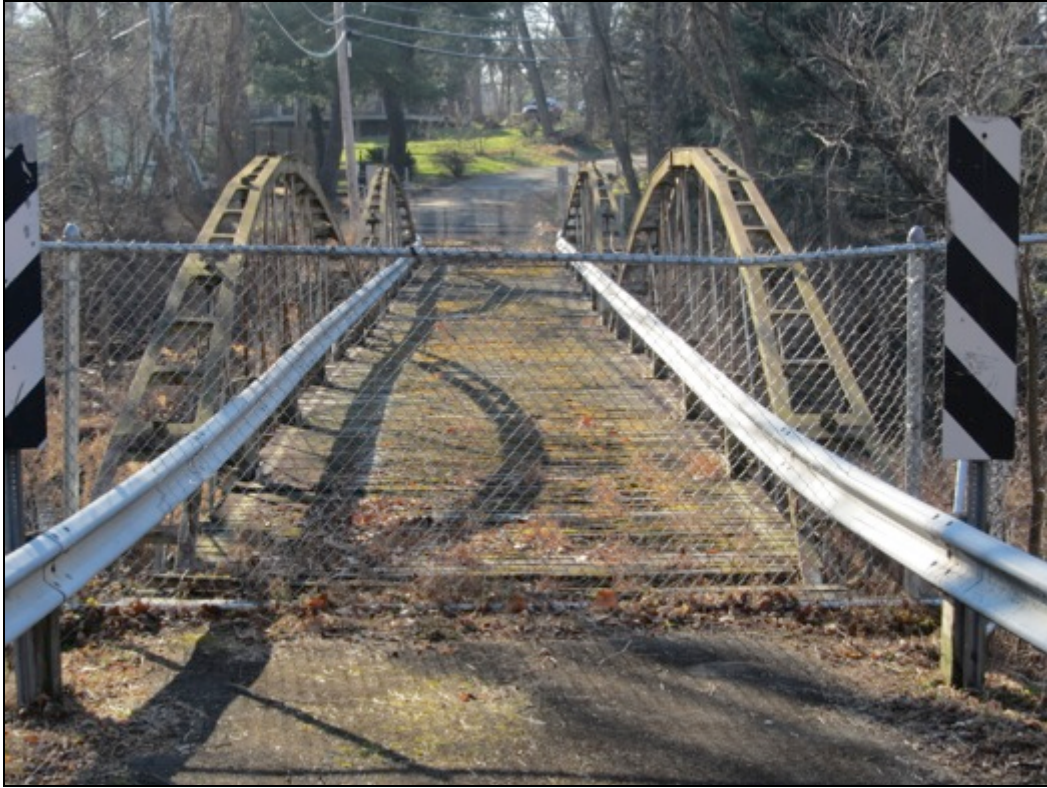
Twin spans looking southerly
