STRUCTURAL CONDITION EVALUATION REPORT SHAW BRIDGE OVER CLAVERACK CREEK

**TOWN OF CLAVERACK
COLUMBIA COUNTY, NEW YORK**

**Ryan-Biggs Project 10322
May 2013
Revised June 2014**

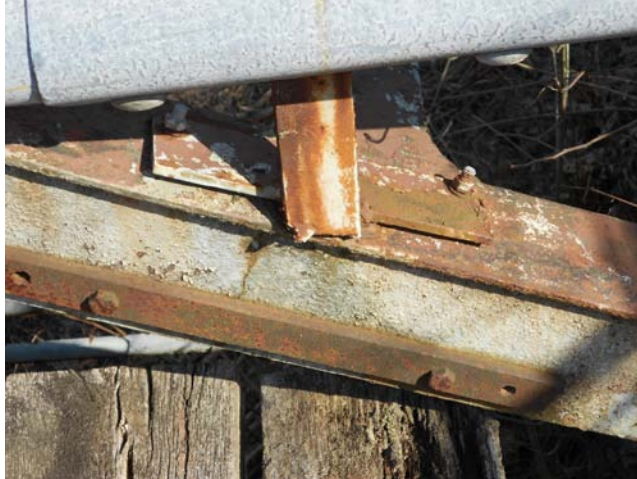
PHOTOGRAPH 1

Item Mark	Location	Observation	Photo	Recommendation	Comment
A	Top Chord Member L0-U1	Bolt hole and crack at railing attachment	1	Remove railing attachment, prepare cracked joint, pre-heat, brazing repair, grind flush	
B	Diagonal Rods Members U3-L4, U4-L3	Broken and bent	2	Remove and replace using steel rods	
C	Joint U5	Bolted steel clamp plate installed at ends of top chord.	3	Remove plates and further investigation is recommended. See description in the recommendations section of the report.	
D	Diagonal Rods Members U5-L6, U6-L5	Broken and bent	4	Remove and replace using steel rods	
E	Vertical Rod Member U6-L6	Bent up to 12 inches	5	Heat straighten in place	
F	Diagonal Rods Members U6-L7, U7-L6	Bent and loose	6	Heat straighten in place Tighten nuts at lower end of loose rods

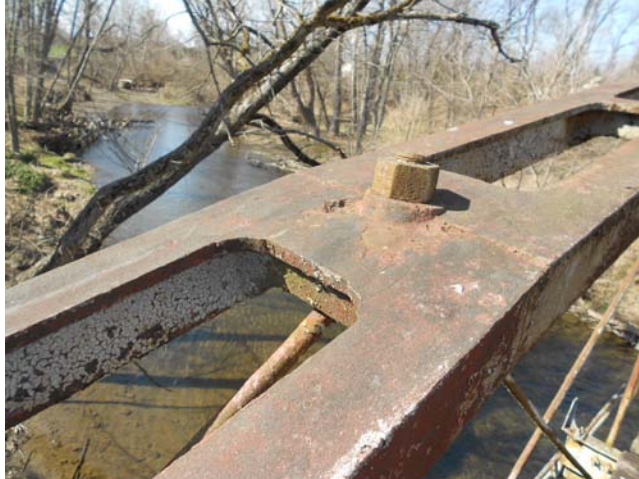
PHOTOGRAPH 7

Item Mark	Location	Observation	Photo	Recommendation	Comment
A	Top Chord Member U1-U2	Small pitting in top of casting near Joint U2	7	No repair required	
B	Diagonal Rods Panels 3 to 6	Diagonal rods are slightly loose	None	Tighten nuts at the lower ends of loose rods	
C	Joint U4	Bolted steel clamp plate installed at ends of top	8 9	Remove plates and further investigation is recommended. See description in the recommendations section of the report.

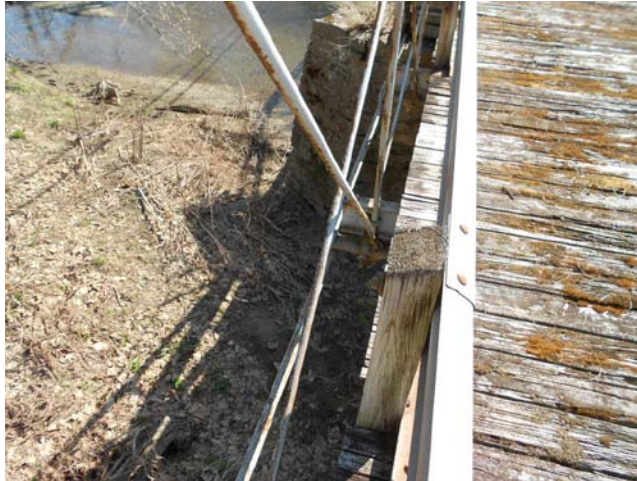
PHOTOGRAPH 10

Item Mark	Location	Observation	Photo	Recommendation	Comment
A	Diagonal Rod Member U3- L2	Diagonal rod is bent and loose	10	Heat straighten in place Tighten nut at lower end	
B	Diagonal Rods Panels 3 to 7	Diagonal rods are slightly loose	None	Tighten nuts at the lower ends of loose rods	
C	Top Chord Member U4-U5	Small chip in edge of casting near Joint U5	11	No repair required	
D	Top Chord Member U3-U4	This casting segment is rotated about 5 degrees about its longitudinal axis with respect to the adjacent segments	12 13 14	Further investigation is recommend. See description in the recommendations section of the report.	Sufficient bearing between casting segments remain.

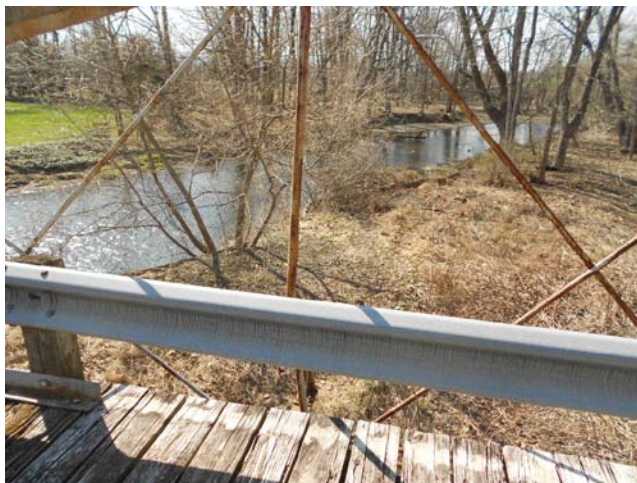
PHOTOGRAPH 15

Item Mark	Location	Observation	Photo	Recommendation	Comment
A	Vertical Rod Member U3-L3	Bent up to 4 to 6 inches Floorbeam is also slightly rotated due to bent rod	15	Heat straighten in place Rotate floorbeam back to vertical	
B	Diagonal Rods Panels 3 to 6	Diagonal rods are loose	16	Tighten nuts at the lower ends of loose rods	
C	Joint U4	Bolted steel clamp plate installed at ends of top chord	17 18	Remove plates and further investigation is recommended. See description in the recommendations section of the report.

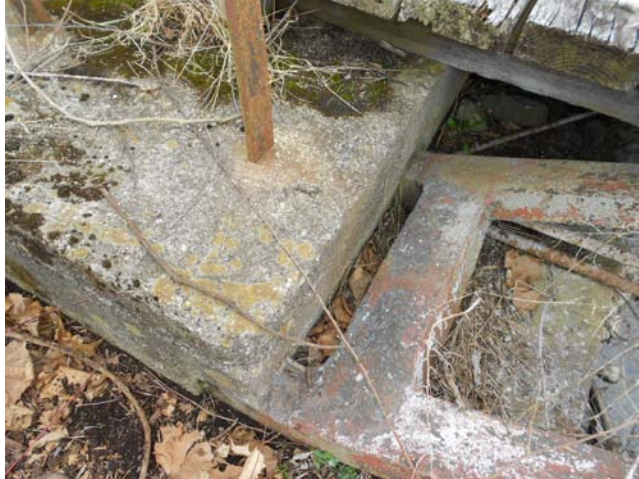
PHOTOGRAPH 19

OBSERVATIONS AND RECOMMENDED REPAIRS					
BRIDGE TRUSSES AND DECK					
Item Mark	Location	Observation	Photo	Recommendation	Comment
A	Truss bearings at each abutment and pier	Ends of top chord at truss bearings are encased in concrete	19	Remove concrete encasement and inspect bearing and connection of lower chord rods to top chord casting.	
B	Top chord of each truss near Joints U1 and U8	W-shape highway rail and single rod railing is bolted and/or welded to the top chord casting	20 21 22	Remove railing attachments and grind welds flush. Fill bolt holes with metalized epoxy filler.	
C	Trusses, floorbeams, bracing, and connections	Metal was painted. The paint is peeling and is in poor condition. The paint is likely lead based.	None	Install environmental containment and blast clean metal surfaces. Inspect cleaned surfaces. Re-paint using zinc-rich primer, epoxy intermediate, and urethane top coat.

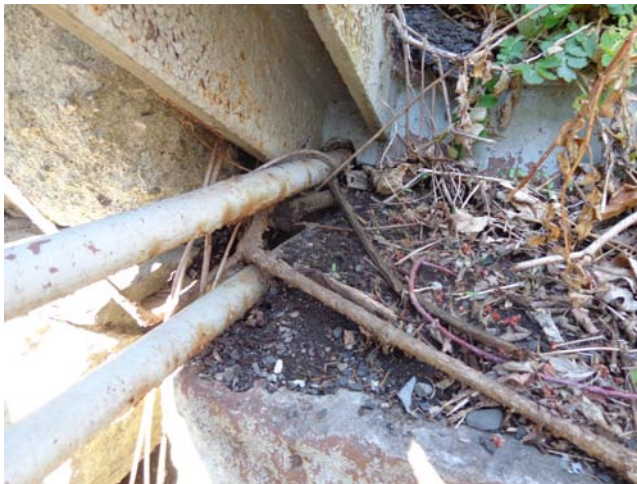
PHOTOGRAPH 23

D	Diagonal and vertical rod connections, lower chord end connections at bearings	Existing rust, dirt, and paint may be hiding a localized necking down of the rods at the connections.	23	Inspect cleaned surfaces at the joints, and evaluate need for repair.	
E	Diagonal Rods	At many locations, typically at the center 3 or 4 truss panels, the rods are loose.	None	Tighten nuts at lower end of loose diagonal rods.	
F	Bridge Deck	Existing wood stringers and wood deck is in poor condition, rotten, and unsafe.	24 25	Remove existing wood stringers and deck. Replace with 2 -1/2 inch treated wood or composite decking.	Limit replacement deck width to 10 feet wide.
G	Rod horizontal X-bracing between floor beams	Rods require inspection after cleaning and deck removal.	26 27	Tighten loose X-bracing rods. Evaluate section loss at abutments and piers, and repair or replace as required.	
H	Railing each side of bridge deck.	Railing does not meet current standards for pedestrian railing.	28	Provide galvanized and painted steel pedestrian railing fabricated to be similar to that shown in historic documents.	Limit width between railing to 10 feet.

Upon blast cleaning the trusses, additional observations are recommended especially at the end connections of the rods where corrosion is typically more severe. Additional observations of the floor beams are also recommended upon removal of the wood bridge deck and blast cleaning.

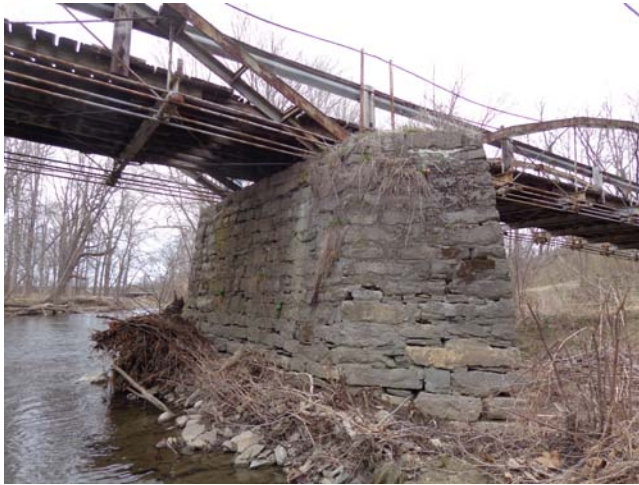
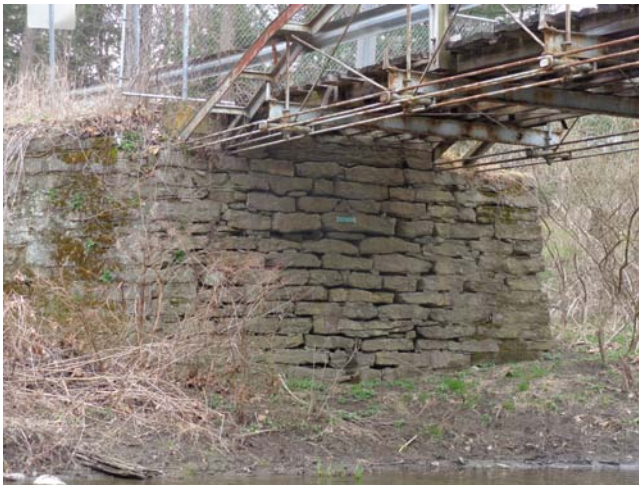
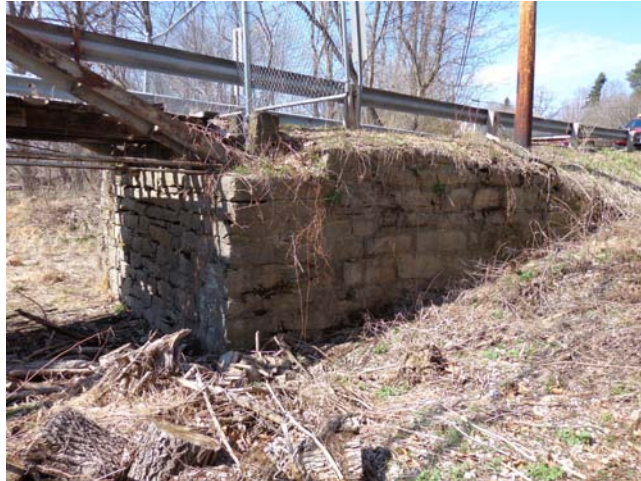
The stone masonry abutments and pier are in generally fair condition, except the mortar in the joints is deteriorated and/or missing.

Item Mark	Location	Observation	Photo	Recommendation	Comment
A	Stone masonry abutments and pier	Mortar between stones is deteriorated and/or missing	29 30 31	Remove deteriorated mortar and repoint stone masonry	Unknown if stone masonry was originally dry-laid, but joints were mortared at some time
B	Stone masonry wingwall at south abutment east side	Several stones at the end of the wingwall are displaced	None	Re-set displaced stone and repoint stone masonry	
C	Stone masonry pier	A scour hole several feet deep at the front and northeast corner; however, pier is not undermined.	32	Fill scour hole and provide stone fill for scour protection.	
D	Each approach	Fencing to restrict access is installed. Highway approach railing not suitable for pedestrian use is installed.	33	Removing fencing and highway railing. Provide walkway pavers and pedestrian railing at each approach. Provide bollards to restrict vehicular access. Provide historical information kiosk. Final grade and establish turf within approach right-of-way.
