SHAW BRIDGE
Claverack, New York

INITIAL SITE VISIT

REPORT

December 13, 2012
Revised December 28, 2013

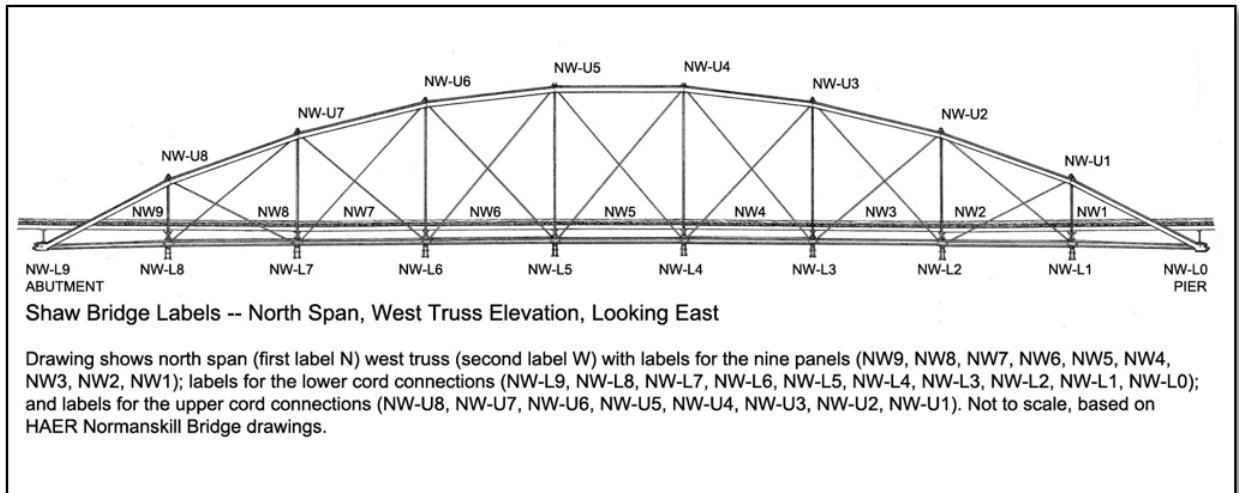
Figure 2

Except where broken (SE-L5, SE-L6, SE-U3, SE-L3) or bent (SE6), as shown in the truss images the diagonals are in good condition. Many of the diagonals are loose and will need to be tightened. As with the verticals necking down of the section can occur where the diagonals enter the cast iron junction blocks. Pack rust is visible in many locations where the diagonals enter the junction block so it is probable that some of the ends of these elements may have to be replaced. All of these areas should be reexamined after the structure is cleaned and any cake or pack rust is removed.

1. Straighten bent diagonals and verticals. This can be done by heating the iron, placing a stiff angle iron along the member and using some type of clamping device pull the bend back flush with the attached angle iron.
2. On broken diagonals or diagonals with significant section loss where they pass through the junction blocks cut off about 3 feet of bar and weld on new mild steel threaded rod.
3. Remove all traces of railing welded to or bolted to the cast iron top chords.
