STRUCTURAL CONDITION EVALUATION REPORT SHAW BRIDGE OVER CLAVERACK CREEK

**TOWN OF CLAVERACK
COLUMBIA COUNTY, NEW YORK**

**Ryan-Biggs Project 10322
May 2013
Revised June 2014**

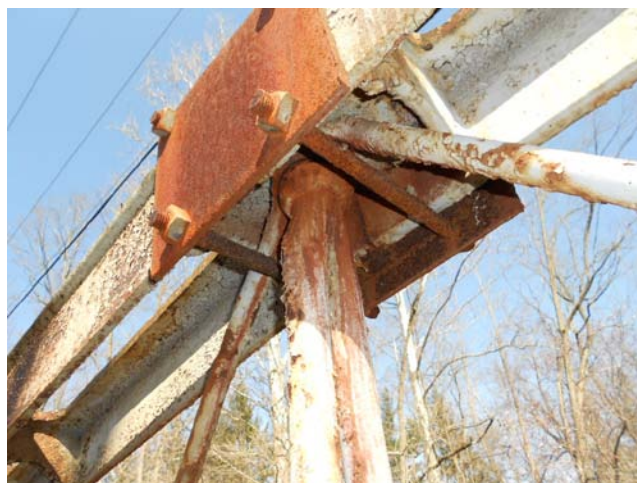
PHOTOGRAPH 2

Item Mark	Location	Observation	Photo	Recommendation	Comment
A	Top Chord Member L0-U1	Bolt hole and crack at railing attachment	1	Remove railing attachment, prepare cracked joint, pre-heat, brazing repair, grind flush	
B	Diagonal Rods Members U3-L4, U4-L3	Broken and bent	2	Remove and replace using steel rods	
C	Joint U5	Bolted steel clamp plate installed at ends of top chord.	3	Remove plates and further investigation is recommended. See description in the recommendations section of the report.	
D	Diagonal Rods Members U5-L6, U6-L5	Broken and bent	4	Remove and replace using steel rods	
E	Vertical Rod Member U6-L6	Bent up to 12 inches	5	Heat straighten in place	
F	Diagonal Rods Members U6-L7, U7-L6	Bent and loose	6	Heat straighten in place Tighten nuts at lower end of loose rods

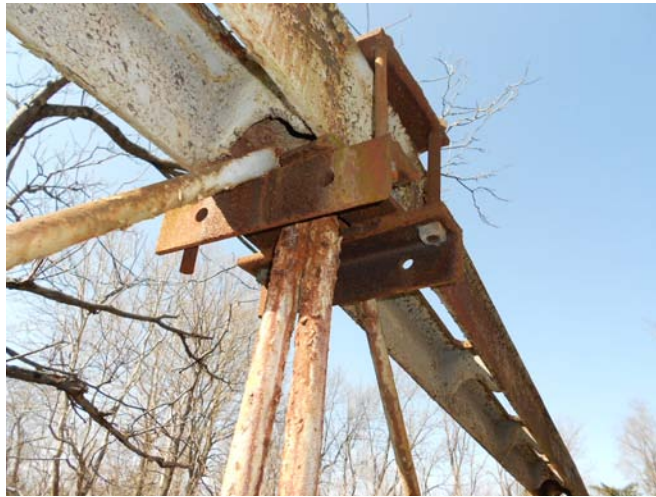
PHOTOGRAPH 7

Item Mark	Location	Observation	Photo	Recommendation	Comment
A	Top Chord Member U1-U2	Small pitting in top of casting near Joint U2	7	No repair required	
B	Diagonal Rods Panels 3 to 6	Diagonal rods are slightly loose	None	Tighten nuts at the lower ends of loose rods	
C	Joint U4	Bolted steel clamp plate installed at ends of top	8 9	Remove plates and further investigation is recommended. See description in the recommendations section of the report.

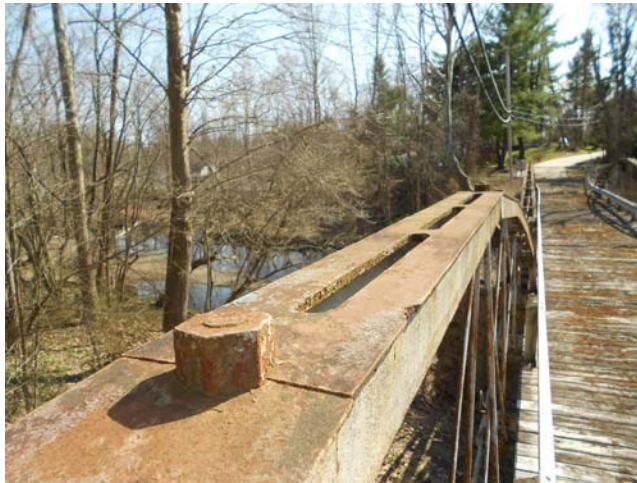
PHOTOGRAPH 10

Item Mark	Location	Observation	Photo	Recommendation	Comment
A	Diagonal Rod Member U3- L2	Diagonal rod is bent and loose	10	Heat straighten in place Tighten nut at lower end	
B	Diagonal Rods Panels 3 to 7	Diagonal rods are slightly loose	None	Tighten nuts at the lower ends of loose rods	
C	Top Chord Member U4-U5	Small chip in edge of casting near Joint U5	11	No repair required	
D	Top Chord Member U3-U4	This casting segment is rotated about 5 degrees about its longitudinal axis with respect to the adjacent segments	12 13 14	Further investigation is recommend. See description in the recommendations section of the report.	Sufficient bearing between casting segments remain.

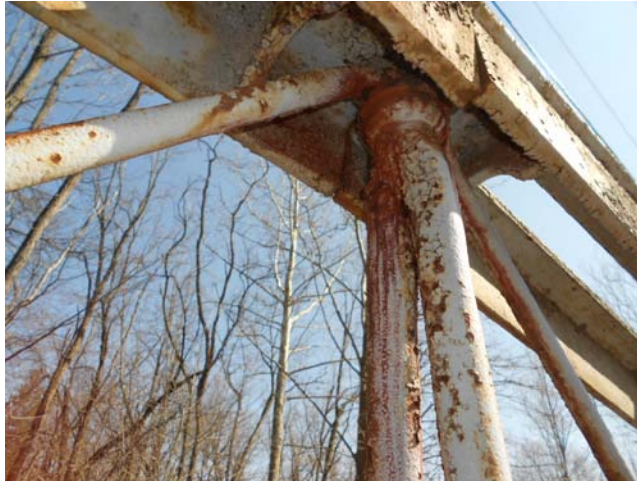
PHOTOGRAPH 12

As noted in Appendix B, at three top chord locations, bolted steel plates were added apparently to help keep the ends of the cast iron segments aligned. At one location, at Truss Mark NE, Member U3-U4 exhibits about a 5 degree rotation about its longitudinal axis with respect to the adjacent segments. The cause for this rotation is unknown, but the bolted steel plates were likely added at the other three locations because of this same condition. It is possible that rusting of the vertical and diagonal rod attachments below the top chord have pushed up unevenly on the bottom surface of the casting due to expansion force of the rusting and caused the rotation. Another explanation is that vibrations due to the dynamic load of vehicular traffic may have contributed to this rotation.

Sufficient bearing remains at the ends of this rotated segment and the vertical rod through the joint between the segments should restrict further rotation. However, further investigation is recommended after blast cleaning, and if it is determined that rusting is the cause for much of this rotation, steps should be taken to disassemble the joint, remove the rust, apply corrosion protection coating, and reassemble the components. This recommendation applies to this rotated member and also to the other top chord members where the bolted steel plates were installed.

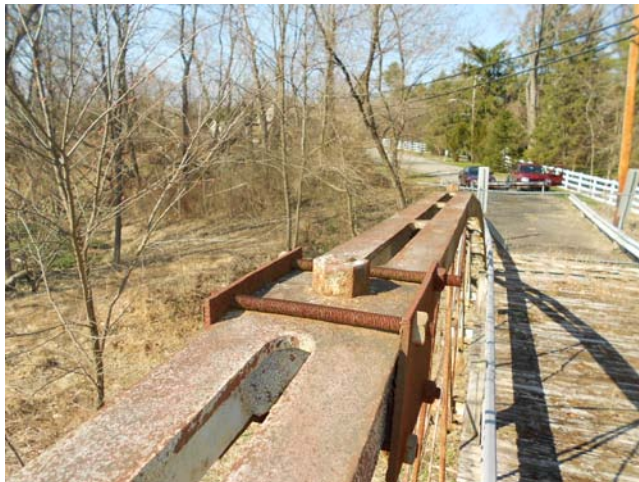
PHOTOGRAPH 16

Item Mark	Location	Observation	Photo	Recommendation	Comment
A	Vertical Rod Member U3-L3	Bent up to 4 to 6 inches Floorbeam is also slightly rotated due to bent rod	15	Heat straighten in place Rotate floorbeam back to vertical	
B	Diagonal Rods Panels 3 to 6	Diagonal rods are loose	16	Tighten nuts at the lower ends of loose rods	
C	Joint U4	Bolted steel clamp plate installed at ends of top chord	17 18	Remove plates and further investigation is recommended. See description in the recommendations section of the report.

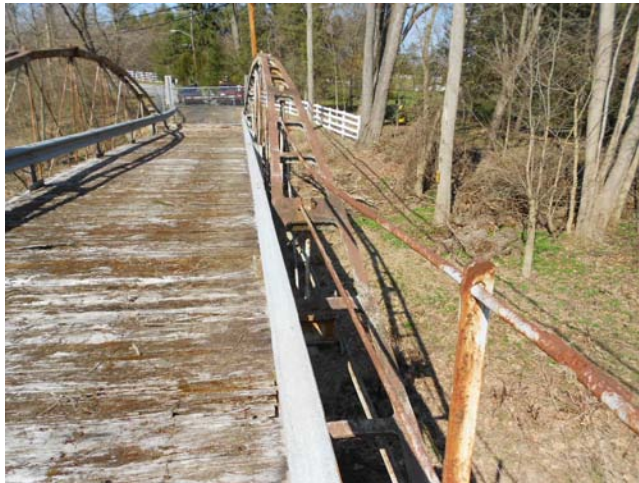
PHOTOGRAPH 19

OBSERVATIONS AND RECOMMENDED REPAIRS					
BRIDGE TRUSSES AND DECK					
Item Mark	Location	Observation	Photo	Recommendation	Comment
A	Truss bearings at each abutment and pier	Ends of top chord at truss bearings are encased in concrete	19	Remove concrete encasement and inspect bearing and connection of lower chord rods to top chord casting.	
B	Top chord of each truss near Joints U1 and U8	W-shape highway rail and single rod railing is bolted and/or welded to the top chord casting	20 21 22	Remove railing attachments and grind welds flush. Fill bolt holes with metalized epoxy filler.	
C	Trusses, floorbeams, bracing, and connections	Metal was painted. The paint is peeling and is in poor condition. The paint is likely lead based.	None	Install environmental containment and blast clean metal surfaces. Inspect cleaned surfaces. Re-paint using zinc-rich primer, epoxy intermediate, and urethane top coat.

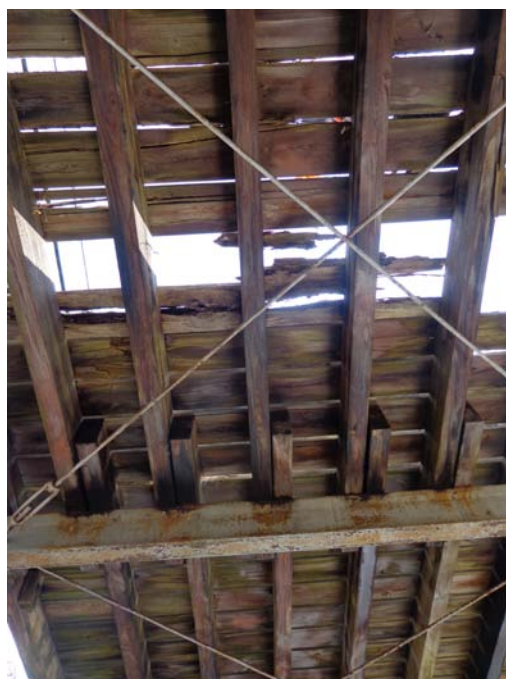
PHOTOGRAPH 23

D	Diagonal and vertical rod connections, lower chord end connections at bearings	Existing rust, dirt, and paint may be hiding a localized necking down of the rods at the connections.	23	Inspect cleaned surfaces at the joints, and evaluate need for repair.	
E	Diagonal Rods	At many locations, typically at the center 3 or 4 truss panels, the rods are loose.	None	Tighten nuts at lower end of loose diagonal rods.	
F	Bridge Deck	Existing wood stringers and wood deck is in poor condition, rotten, and unsafe.	24 25	Remove existing wood stringers and deck. Replace with 2 -1/2 inch treated wood or composite decking.	Limit replacement deck width to 10 feet wide.
G	Rod horizontal X-bracing between floor beams	Rods require inspection after cleaning and deck removal.	26 27	Tighten loose X-bracing rods. Evaluate section loss at abutments and piers, and repair or replace as required.	
H	Railing each side of bridge deck.	Railing does not meet current standards for pedestrian railing.	28	Provide galvanized and painted steel pedestrian railing fabricated to be similar to that shown in historic documents.	Limit width between railing to 10 feet.

Upon blast cleaning the trusses, additional observations are recommended especially at the end connections of the rods where corrosion is typically more severe. Additional observations of the floor beams are also recommended upon removal of the wood bridge deck and blast cleaning.

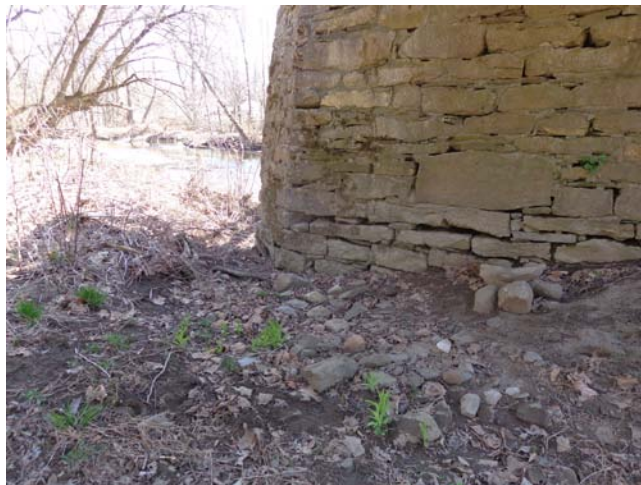
PHOTOGRAPH 31

Item Mark	Location	Observation	Photo	Recommendation	Comment
A	Stone masonry abutments and pier	Mortar between stones is deteriorated and/or missing	29 30 31	Remove deteriorated mortar and repoint stone masonry	Unknown if stone masonry was originally dry-laid, but joints were mortared at some time
B	Stone masonry wingwall at south abutment east side	Several stones at the end of the wingwall are displaced	None	Re-set displaced stone and repoint stone masonry	
C	Stone masonry pier	A scour hole several feet deep at the front and northeast corner; however, pier is not undermined.	32	Fill scour hole and provide stone fill for scour protection.	
D	Each approach	Fencing to restrict access is installed. Highway approach railing not suitable for pedestrian use is installed.	33	Removing fencing and highway railing. Provide walkway pavers and pedestrian railing at each approach. Provide bollards to restrict vehicular access. Provide historical information kiosk. Final grade and establish turf within approach right-of-way.
